## BRADFORD RANGER DISTRICT

## OIL AND GAS INSPECTION REPORT

OGM Case Numbers: 243, 244 and 245 Date of Inspection: December 03, 2007  
 Weather Conditions: Cloudy, 30's F Persons On-Site: None  
 Warrant/Lot Number: Warrants 2752 & 2445 Mineral Owner/Leasee: Duhring Resource Company  
 Lots 7, 9,  
 Project: To be determined Inspector: Gomola  
 Discussed Operation With: Only FS employees to date  
 Equipment On-Site: None  
 Activity On-Site: Proposed roads and wells were flagged/marked, construction had been begun  
 on part of the package

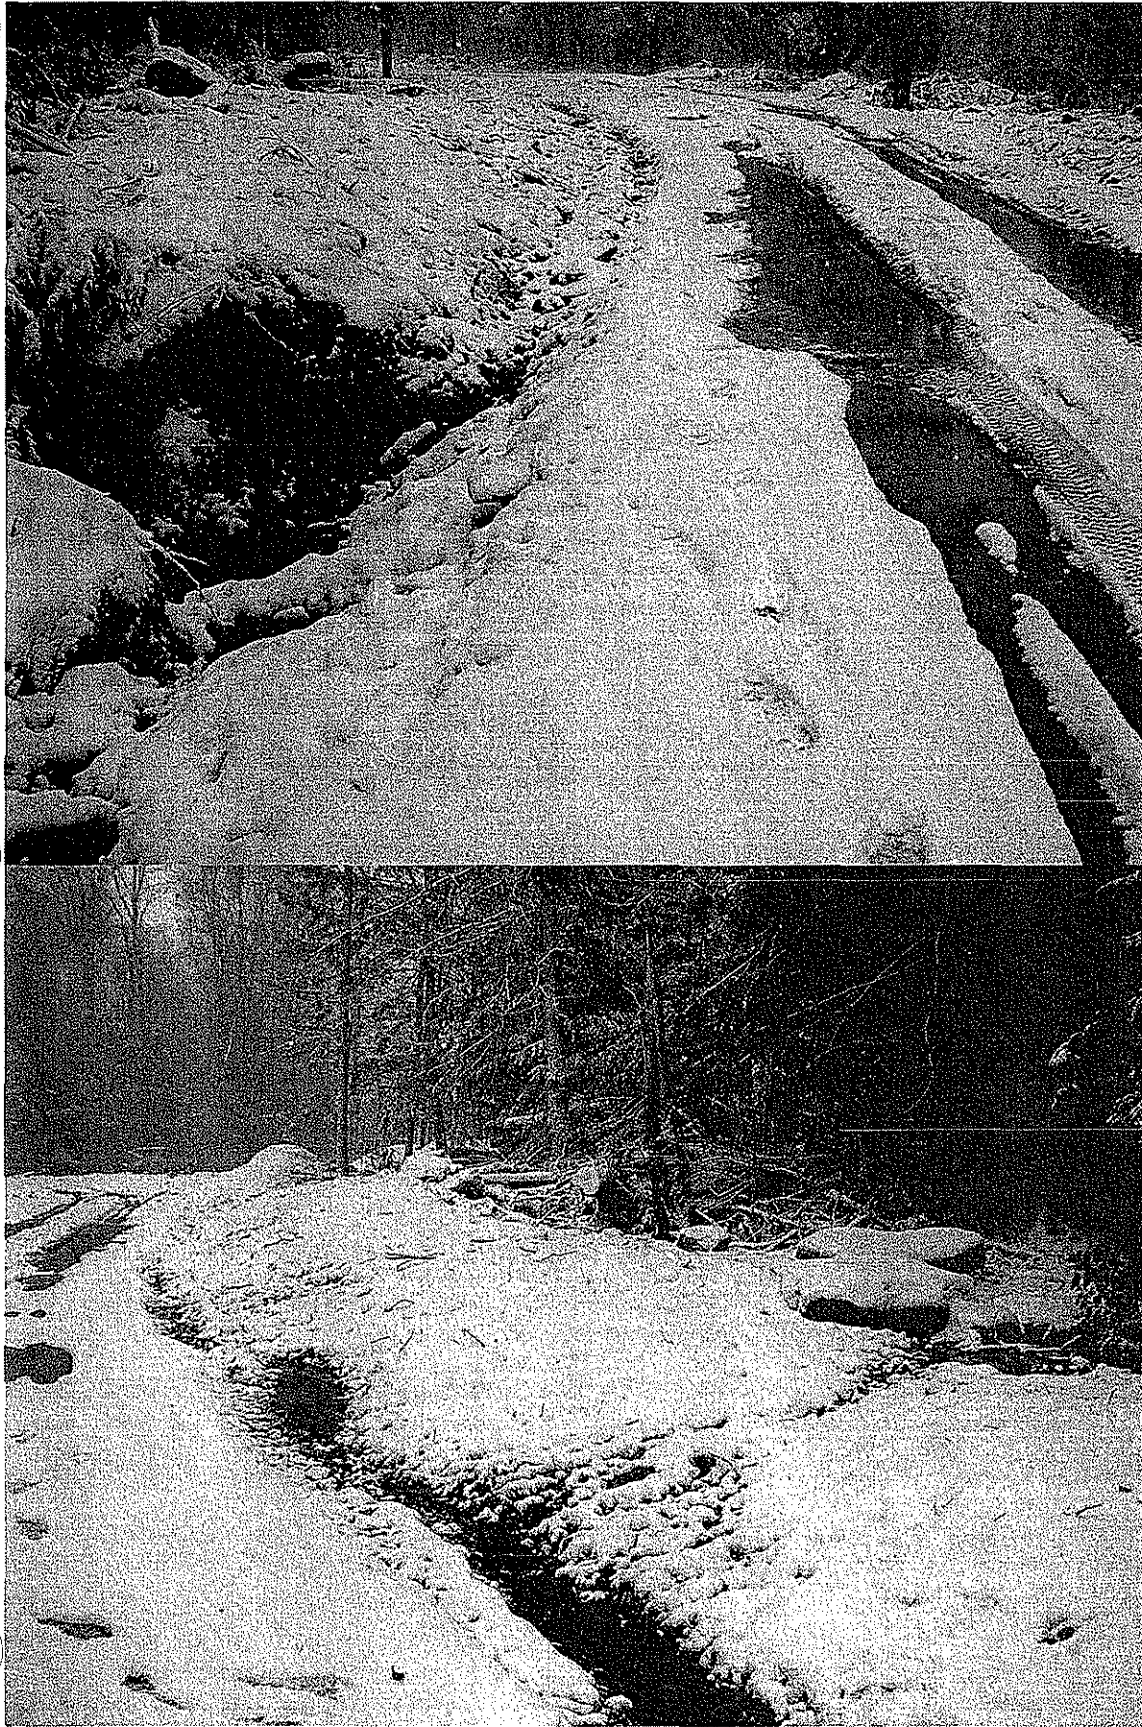
- Two well locations 7-17 and 7-19 are visible from SR 948, a Concern Level 1 road in regards to scenery management.
- Well location 7-19 appeared to be approximately 100 feet from South Branch Tionesta Creek. Also, the access road is in a very wet area. Standing water was observed in the road over the culvert location. There were no E & S controls seen on location. Frac pit was unlined. Overburden from road construction was pushed past ROW boundary marking. (see pictures for well 19 in folder)

Well 19  
Picture 1  
culvert and  
standing water.  
No E&S  
controls

Picture 2  
ditchline  
channeling  
springs

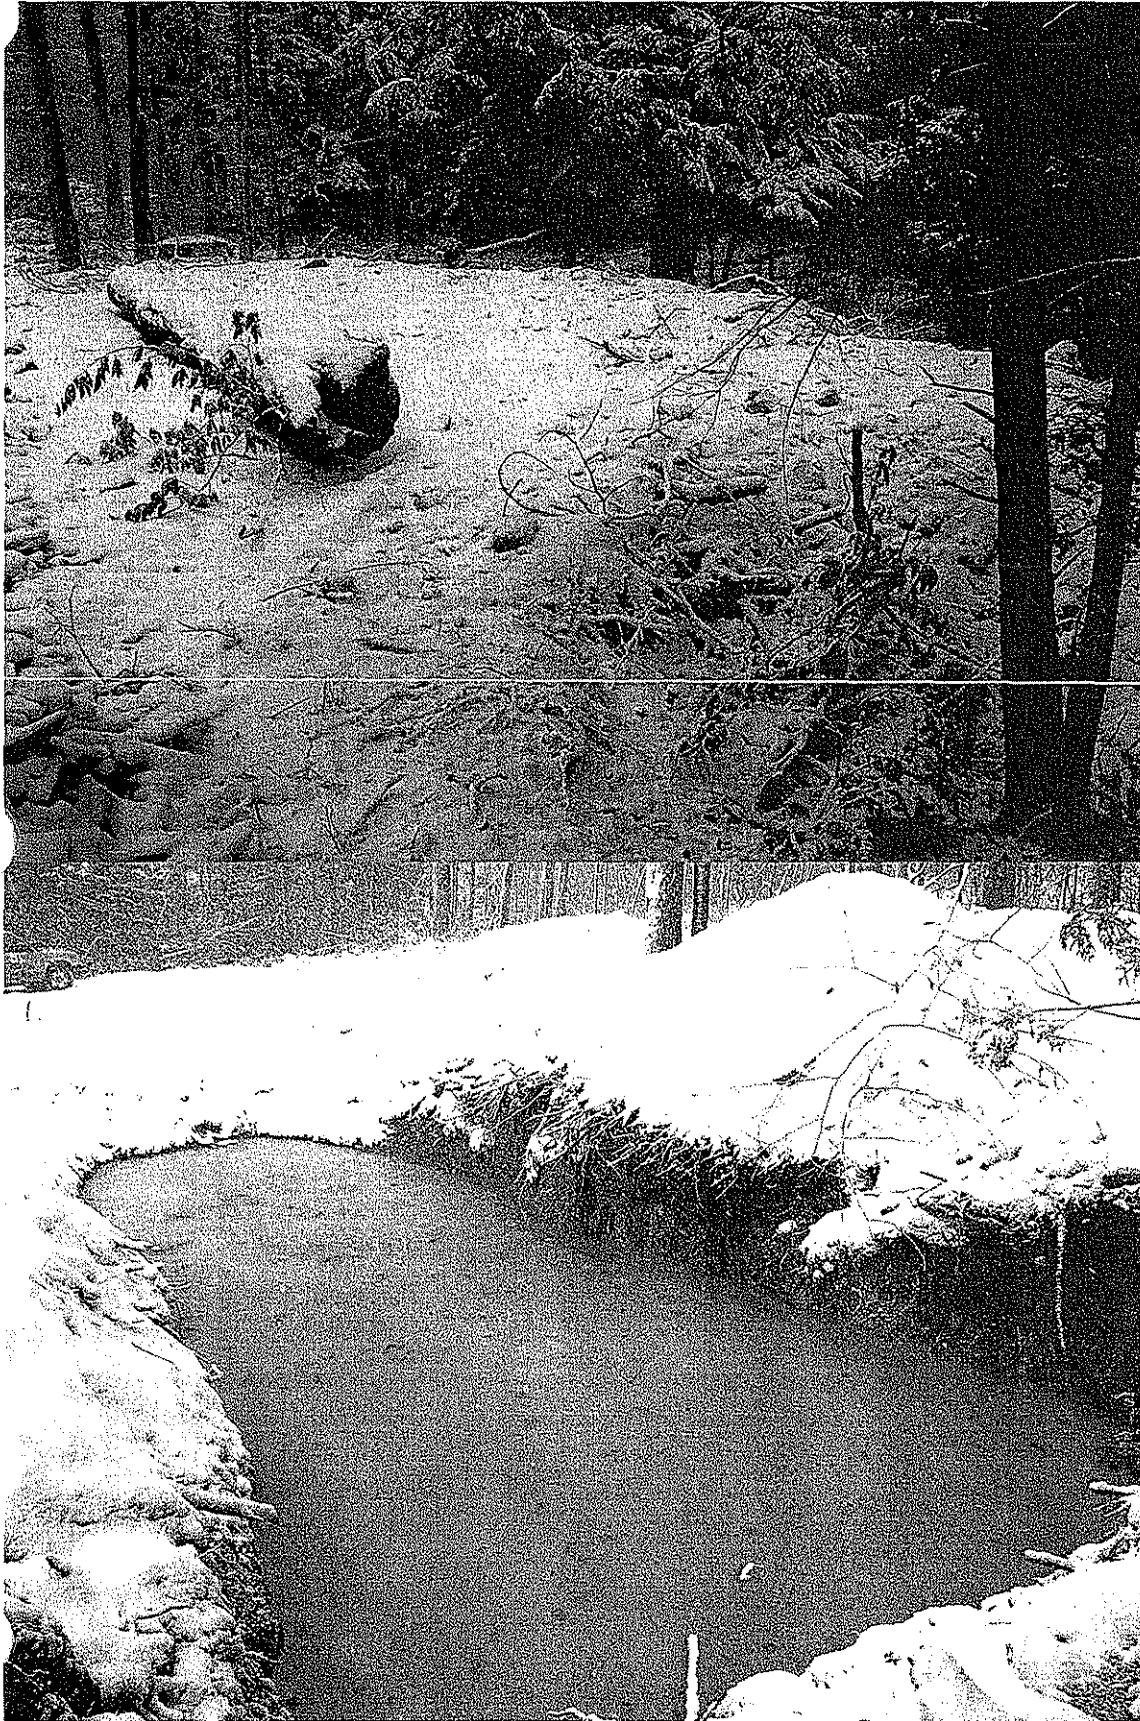
Well 19  
Picture 3  
overburden  
past boundary

Picture 4 frac  
pit without  
liner.

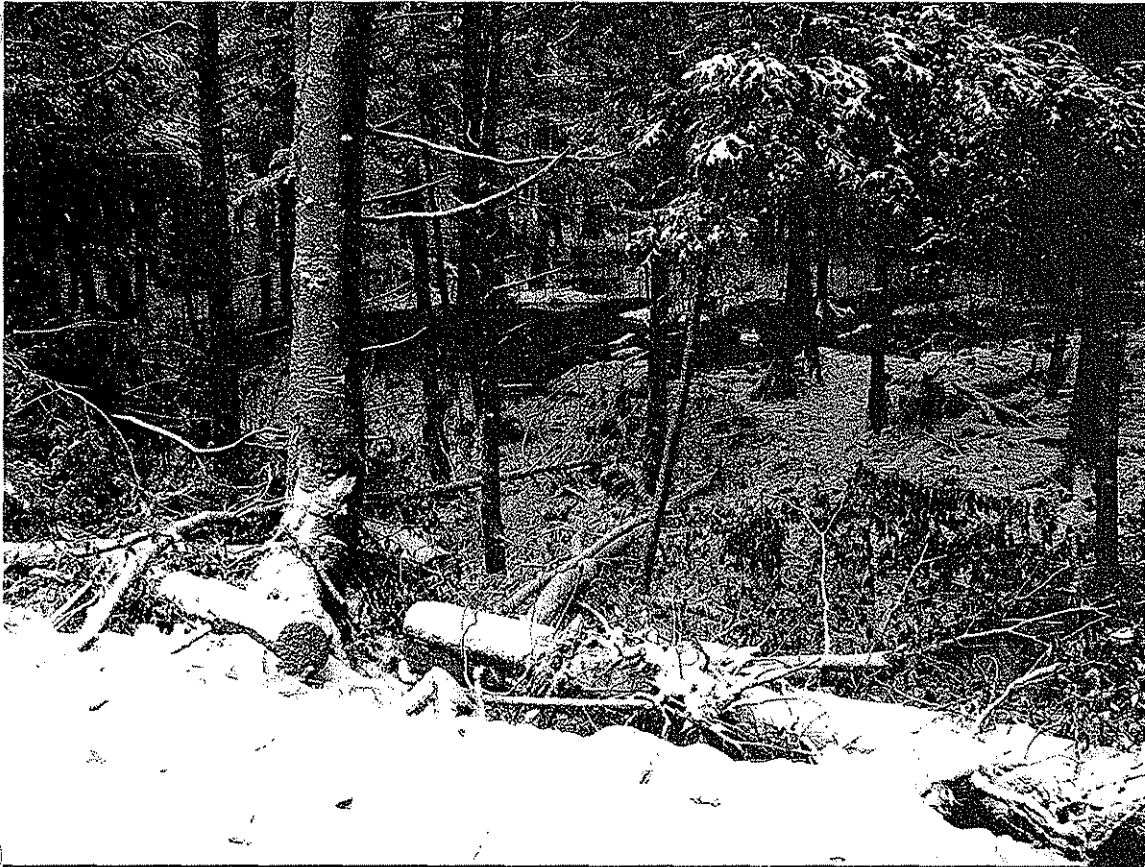
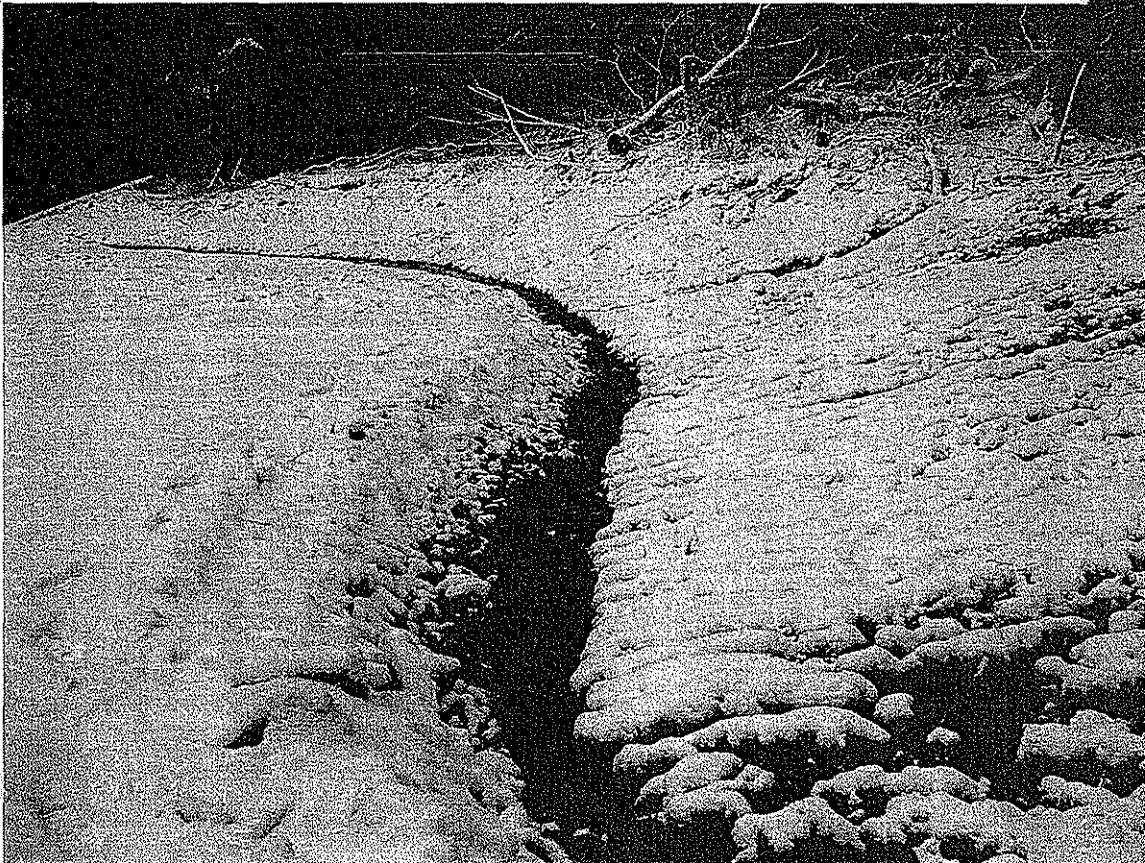
- Well location 7-18 is very close to and visible from the North Country Trail. The ditch for access road captures water from multiple springs which creates a wetland down hill from location. There were no E & S controls seen on location. Frac pit was unlined. (see pictures for well 18 in folder)

Pictures 5 and  
6 are of well  
18.  
Picture 7 is the  
observed  
pipeline ROW

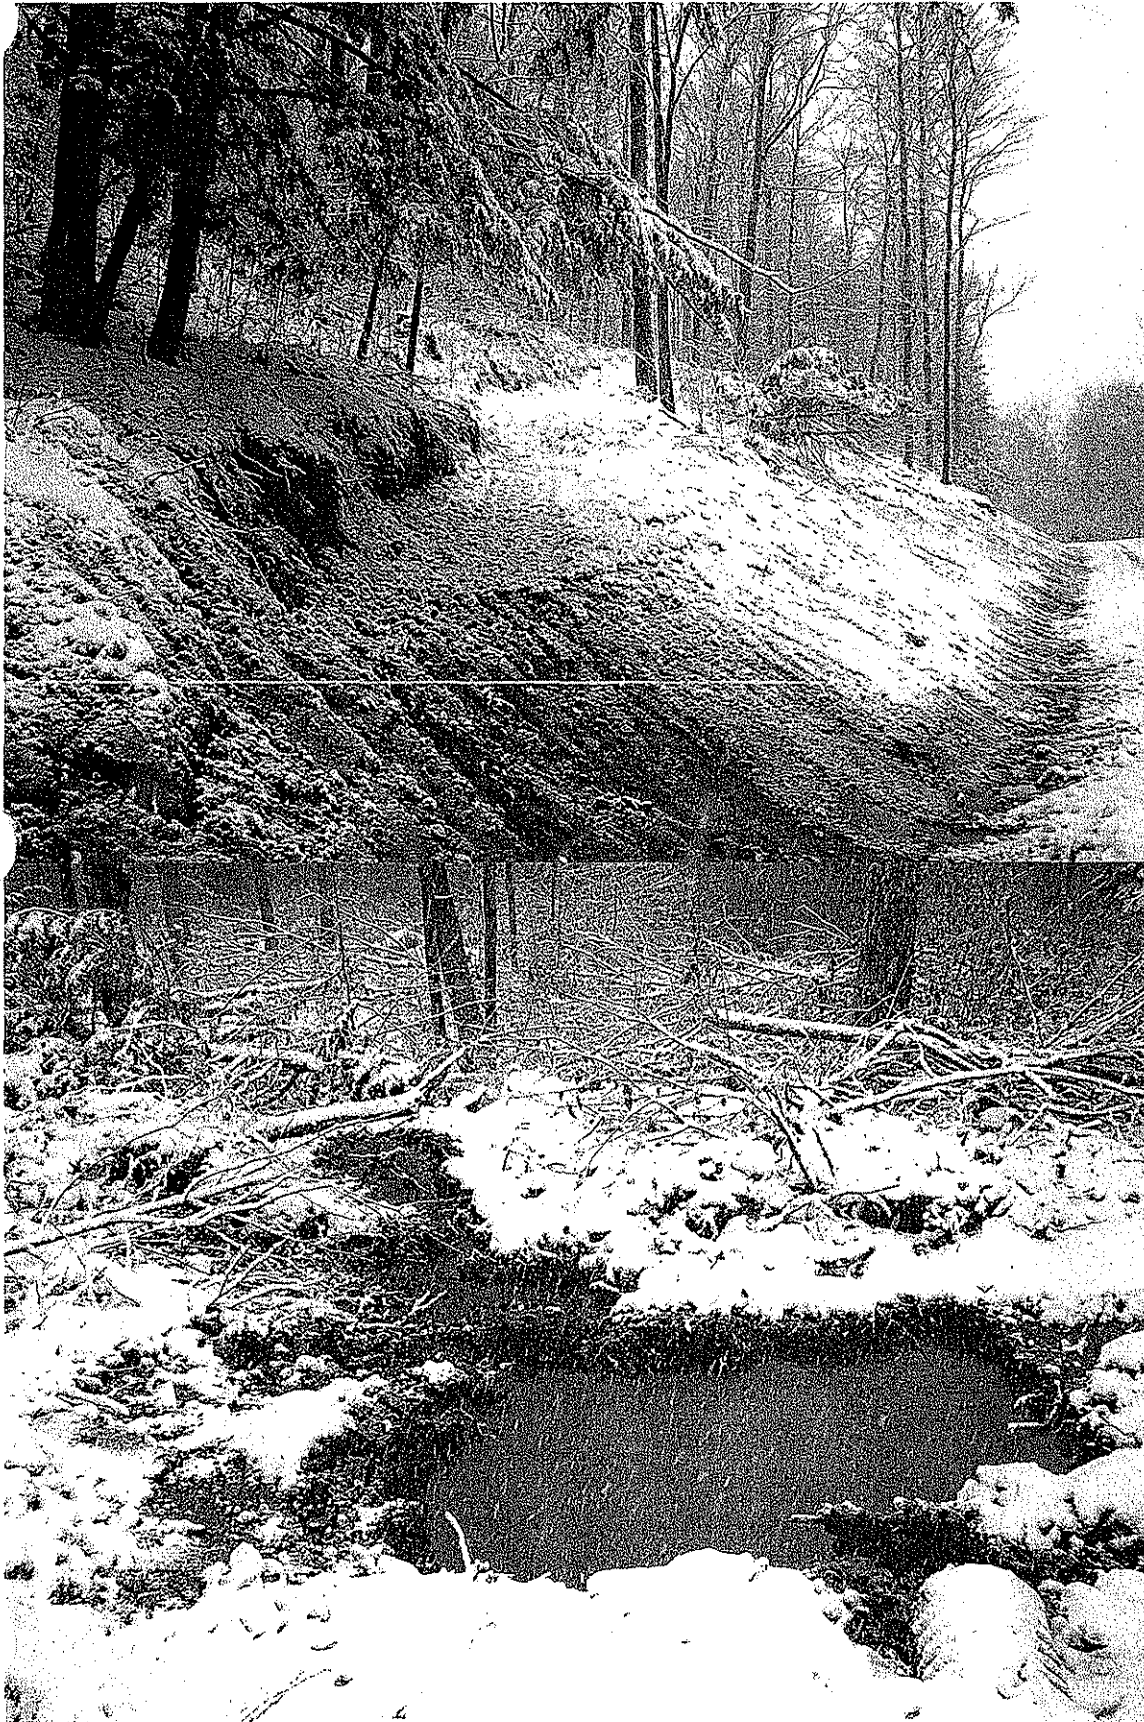
- Pipeline ROW between existing road and access road to wells 14, 21, and 22 observed and photographed. This ROW was not indicated on the map and may not have been approved by the Forest Service. (see pictures for Lot7-unauth-pipeline in folder)

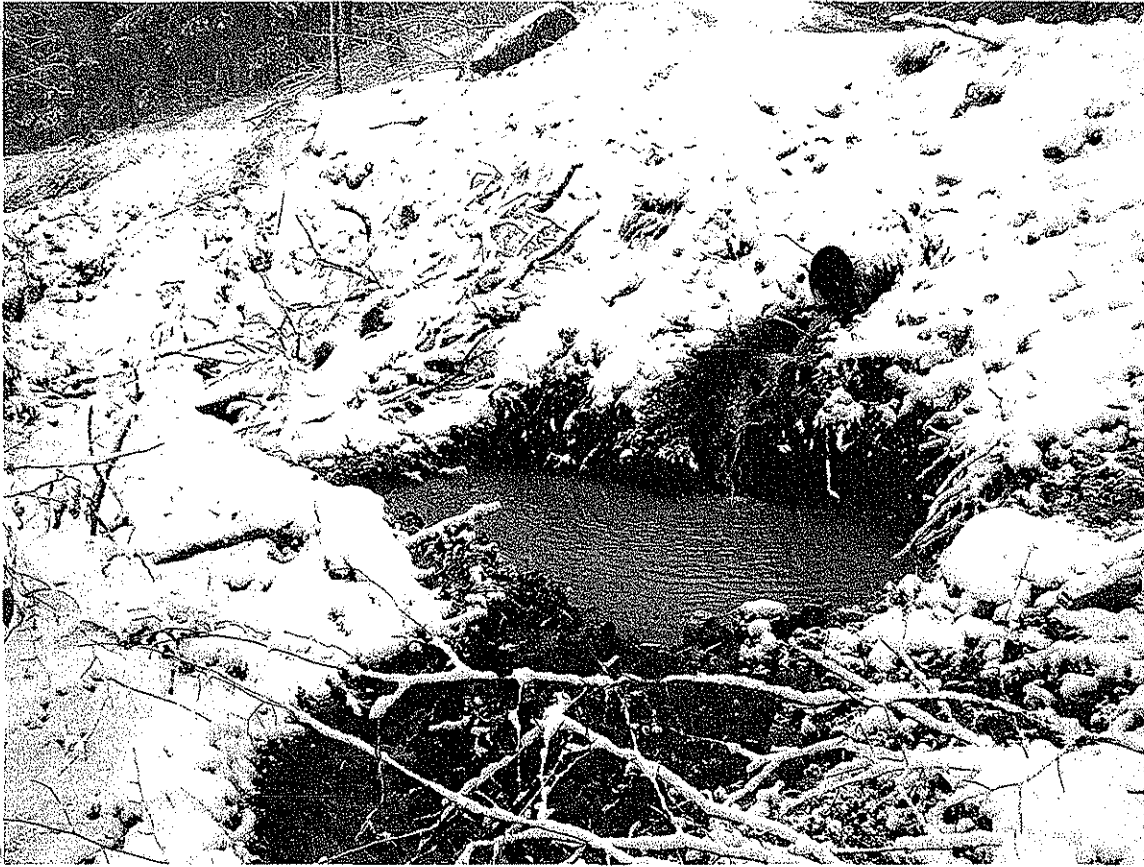
- Access road to wells 21 and 22 has had timber removed and is under construction. There is a poorly placed culvert before the fork in the road leading to well 14, 21, and 22. No E&S controls in place at culvert location just a sediment pond made of on site materials. (see pictures for Lot7-culvert in folder)

Pictures 8 and  
9 are the  
culvert  
sediment pond.
