## BRADFORD RANGER DISTRICT

## OIL AND GAS INSPECTION REPORT

OGM Case Numbers: 243, 244 and 245 Date of Inspection: December 03, 2007  
 Weather Conditions: Cloudy, 30's F Persons On-Site: None  
 Warrant/Lot Number: Warrants 2752 & 2445 Mineral Owner/Leasee: Duhring Resource Company  
 Lots 7, 9,  
 Project: To be determined Inspector: Gomola  
 Discussed Operation With: Only FS employees to date  
 Equipment On-Site: None  
 Activity On-Site: Proposed roads and wells were flagged/marked, construction had been begun on part of the package

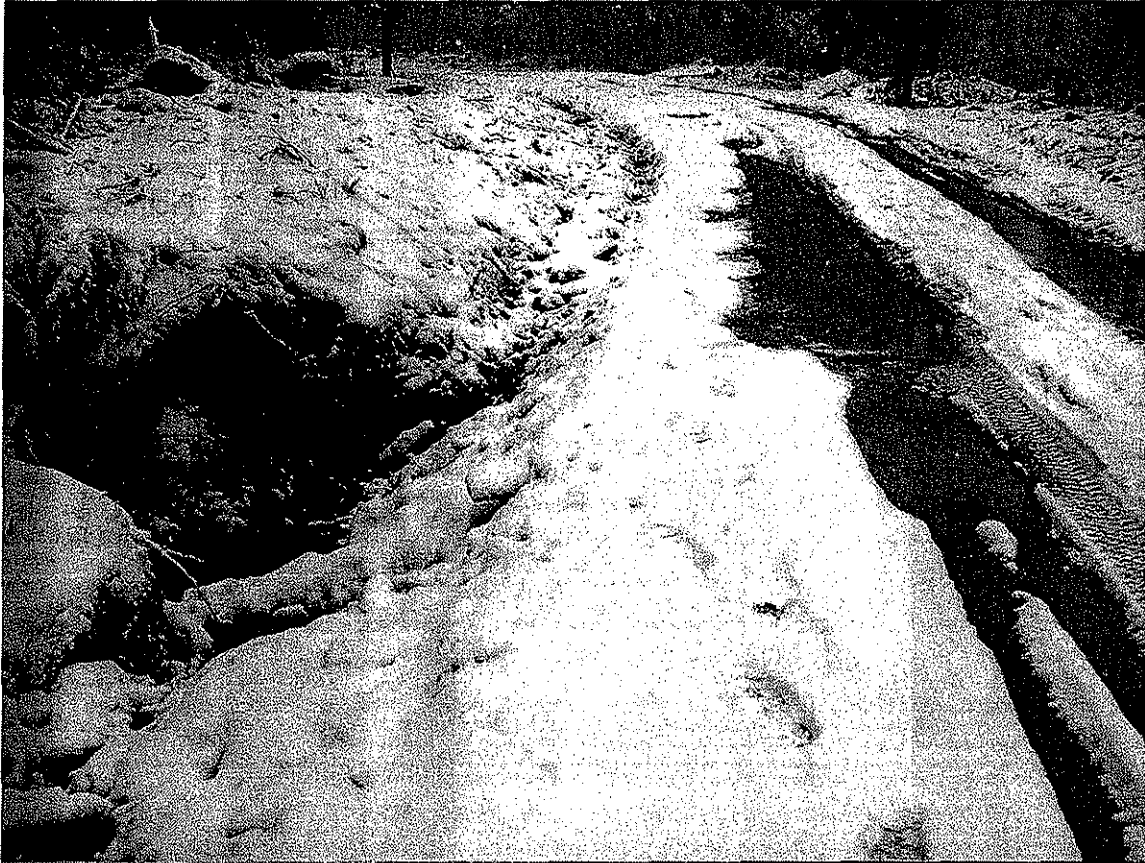
- Two well locations 7-17 and 7-19 are visible from SR 948, a Concern Level 1 road in regards to scenery management.
- Well location 7-19 appeared to be approximately 100 feet from South Branch Tionesta Creek. Also, the access road is in a very wet area. Standing water was observed in the road over the culvert location. There were no E &S controls seen on location. Frac pit was unlined. Overburden from road construction was pushed past ROW boundary marking. (see pictures for well 19 in folder)

Well 19  
Picture 1  
culvert and  
standing water.  
No E&S  
controls

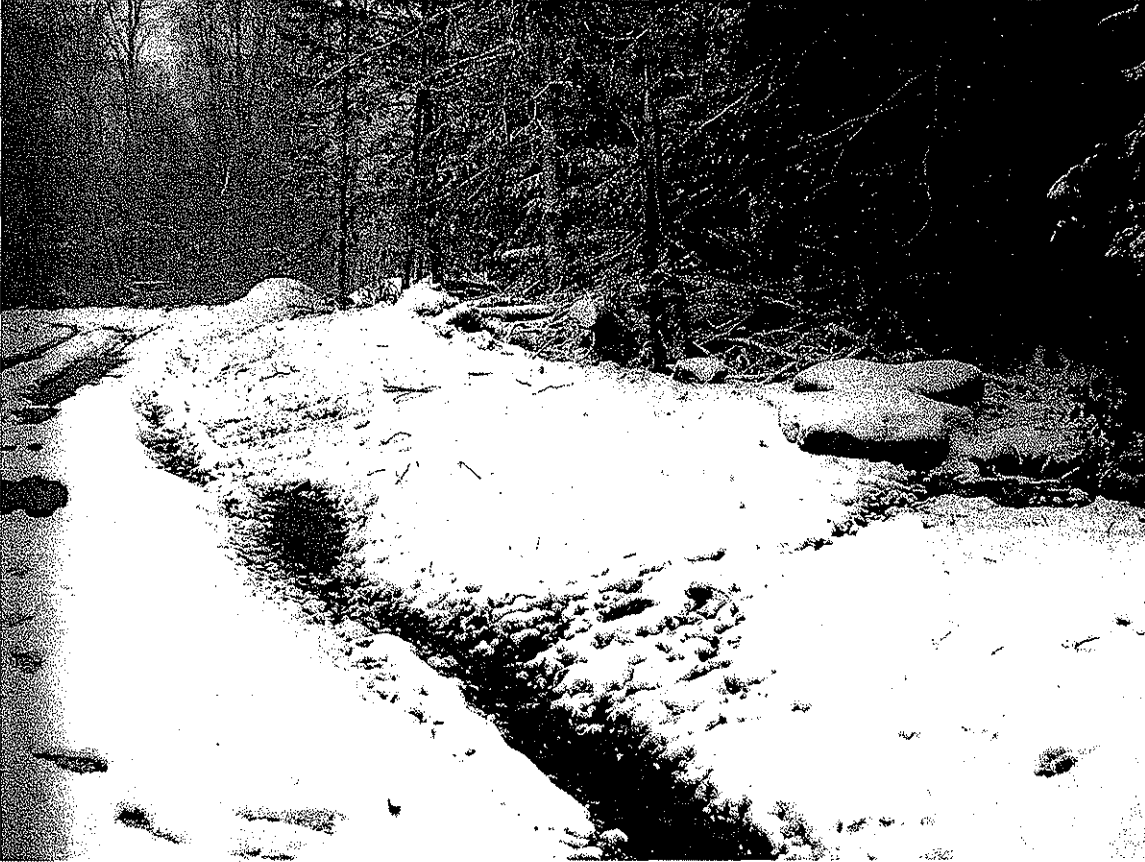
- Well location 7-18 is very close to and visible from the North Country Trail. The ditch for access road captures water from multiple springs which creates a wetland down hill from location. There were no E &S controls seen on location. Frac pit was unlined. (see pictures for well 18 in folder)

Picture 2  
ditchline  
channeling  
springs

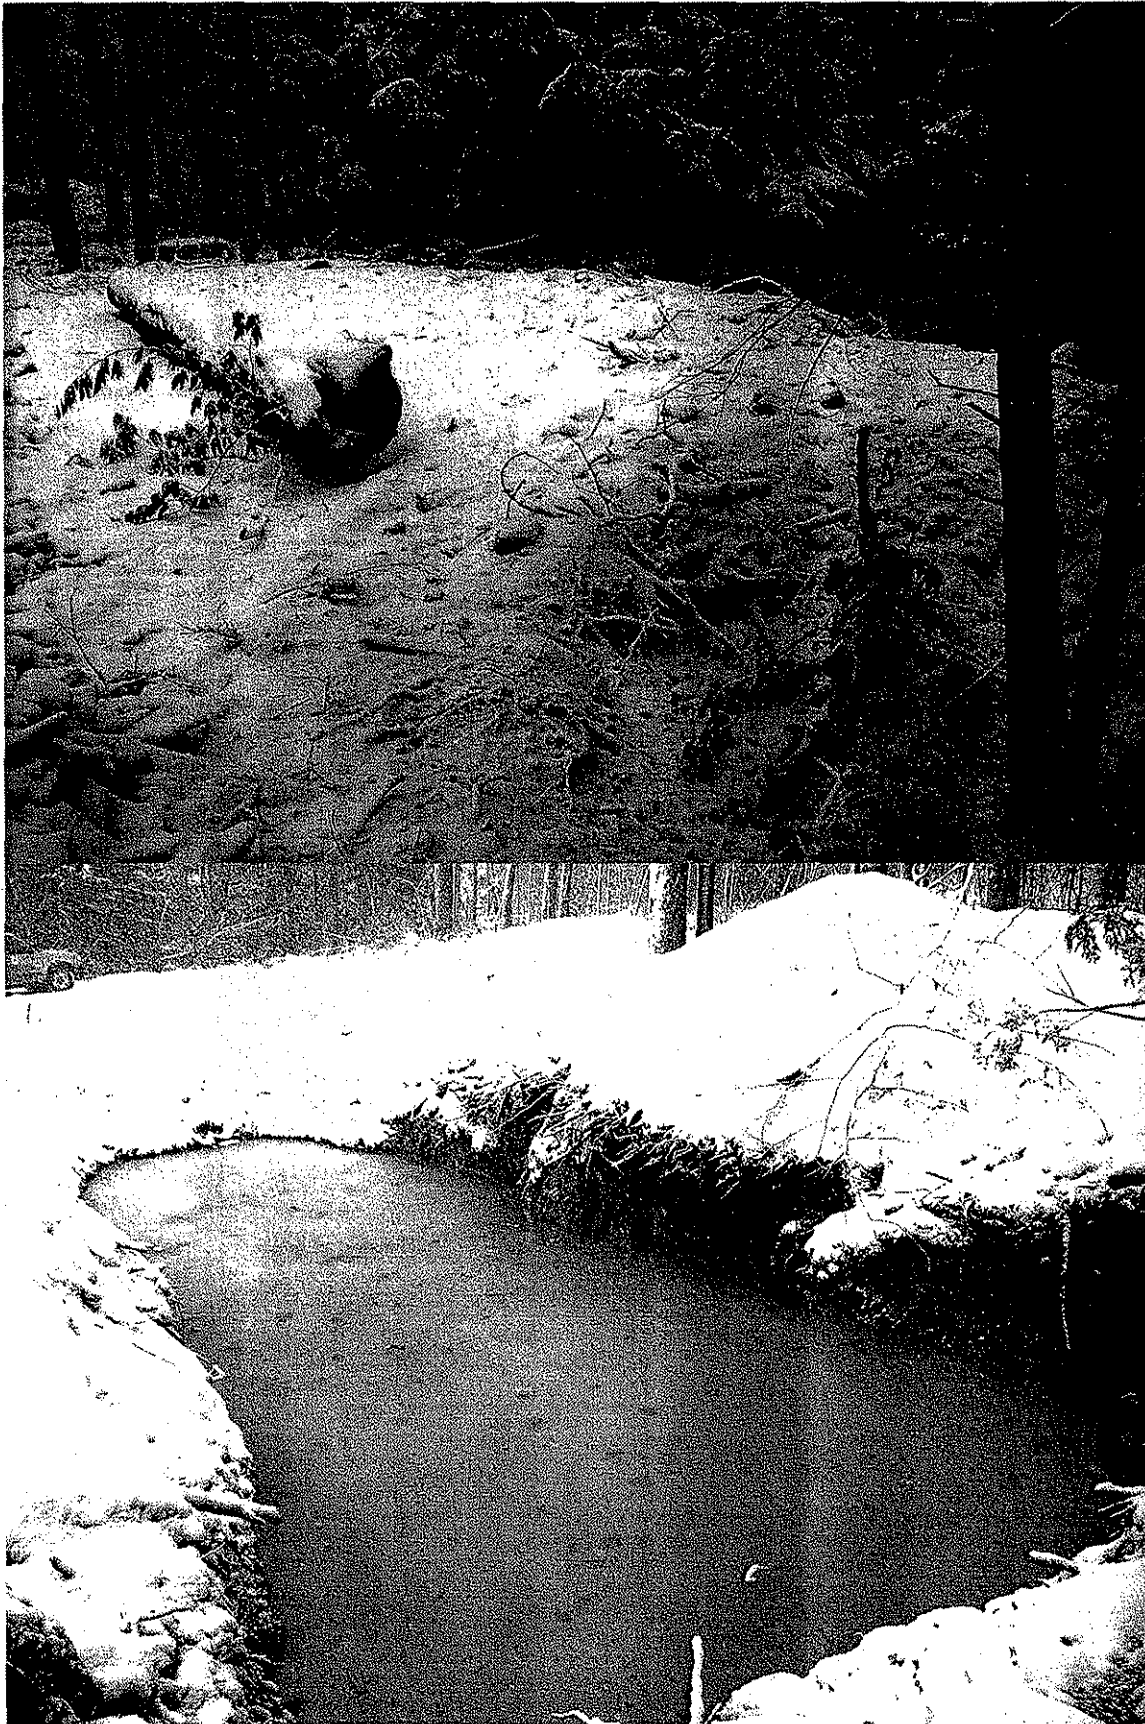
Well 19  
Picture 3  
overburden  
past boundary

Picture 4 frac  
pit without  
liner.

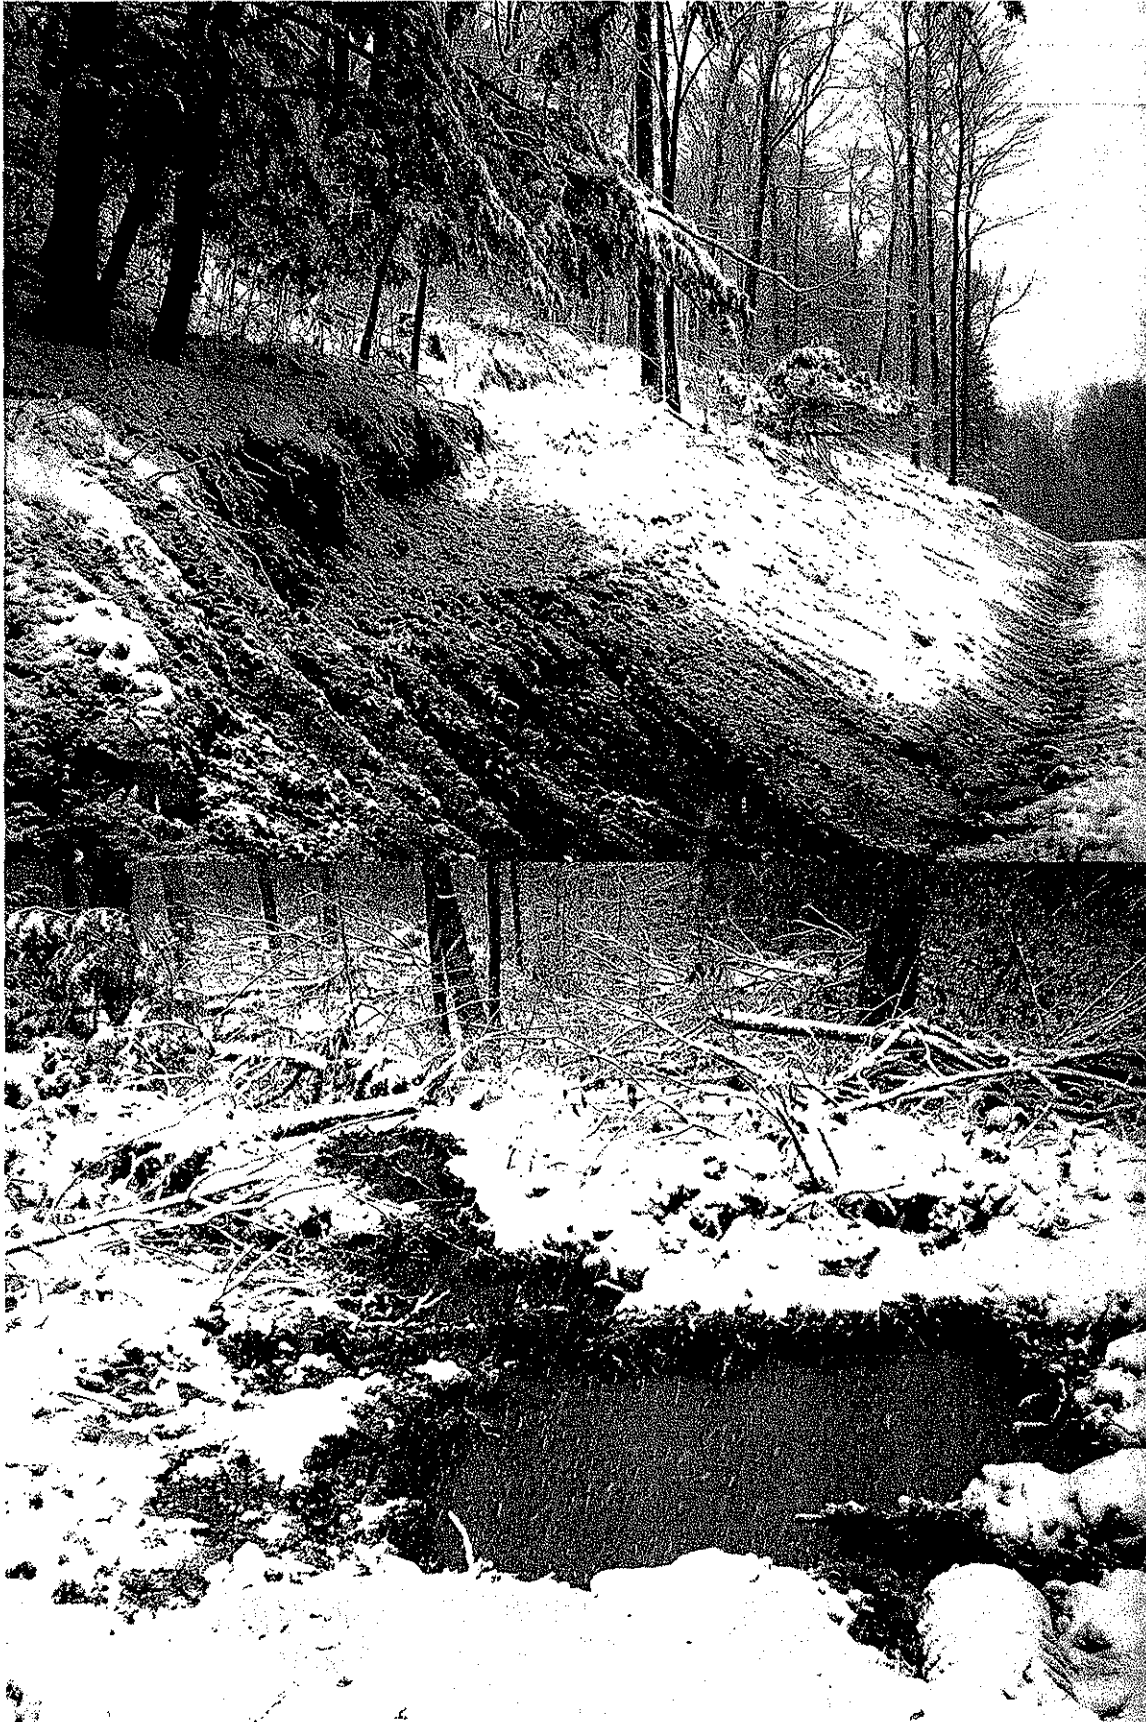
Picture 7 is the  
observed  
pipeline ROW

- Pipeline ROW between existing road and access road to wells 14, 21, and 22 observed and photographed. This ROW was not indicated on the map and may not have been approved by the Forest Service. (see pictures for Lot7-unauth-pipeline in folder)

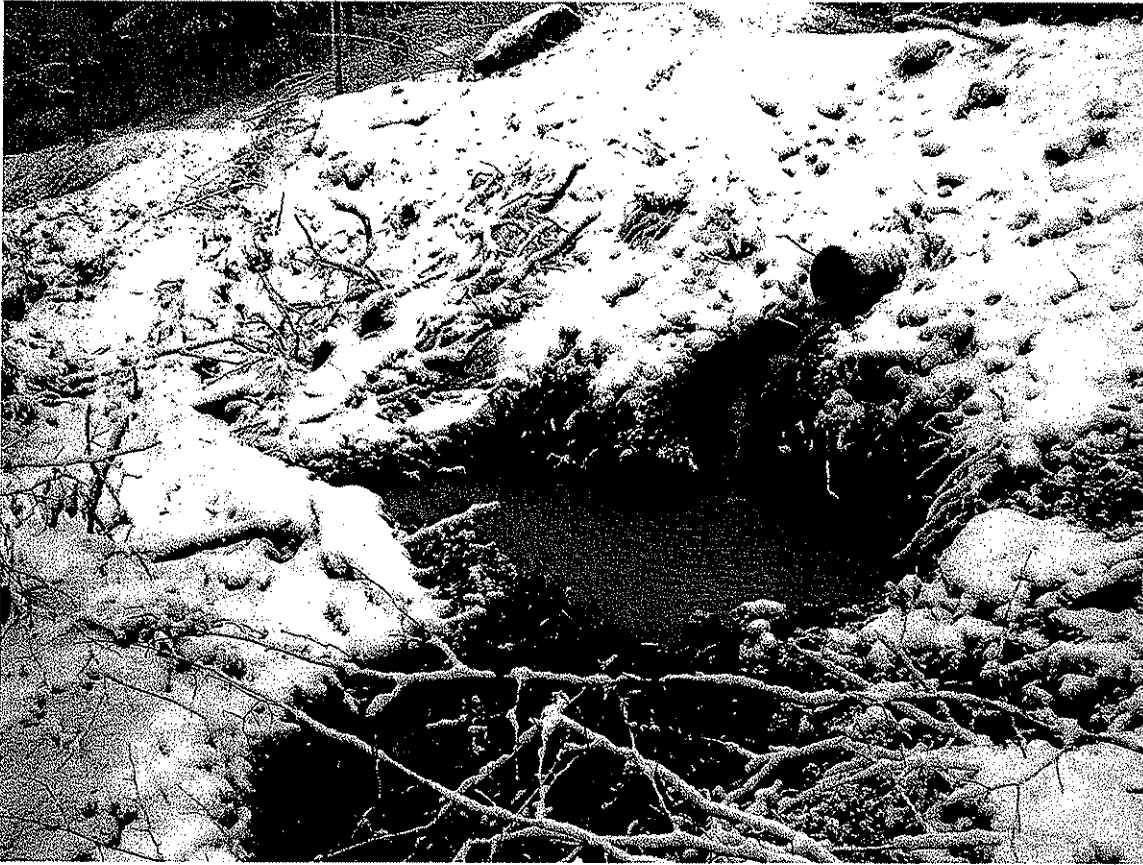
Pictures 8 and  
9 are the  
culvert  
sediment pond.

- Access road to wells 21 and 22 has had timber removed and is under construction. There is a poorly placed culvert before the fork in the road leading to well 14, 21, and 22. No E&S controls in place at culvert location just a sediment pond made of on site materials. (see pictures for Lot7-culvert in folder)
